INDIANAPOLIS
HISTORIC
PRESERVATION
COMMISSION

ST. JOSEPH HISTORIC AREA PLAN

Historic Area Preservation Plan
ST. JOSEPH HISTORIC AREA

(HD-25 (SJ))

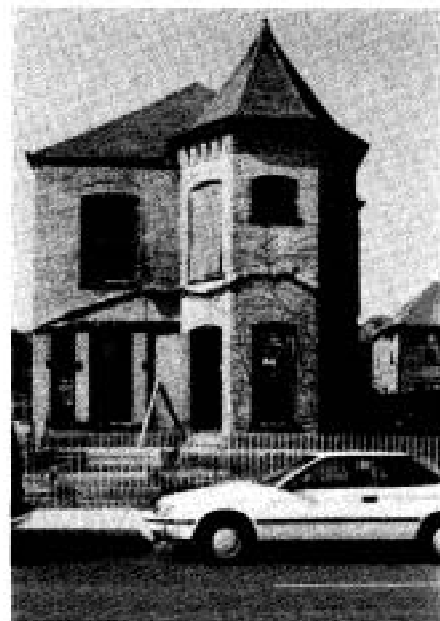
Christian-Kave House
832 North Alabama
circa 1890

Architectural Description: The Christian-Kave House is a frame, three-story structure designed in the Queen Anne style. It has an asymmetrical floor plan with a tower located at the northeast corner of the structure. Gabled bays face north and east and the roof line features several gabled dormers. The 1994 rehabilitation project resulted in the removal of plaster sheathing and several twentieth century brick porches to reveal a variety of Queen Anne detailing. Gable eaves have applied decorative barge boards. The tower has a pyramidal roof with evidence of its original metal cresting still evident. The third floor of the tower and the dormers are sheathed in fish scale shingles. Windows are one-over-one wood sash and are trimmed in flat wood elements. Some tower windows retain applied wood details featuring a sunburst motif.

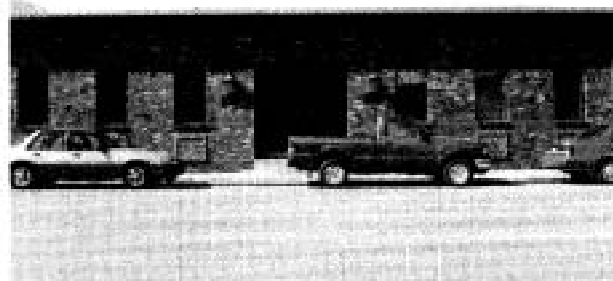
Commercial Building
801-807 North Delaware Street
circa 1935

Architectural Description: The two street facades are faced with sheet metal and brick and are of a recent vintage. The window and door openings on the Delaware Street facade give no hint of the original storefronts now covered with brick.

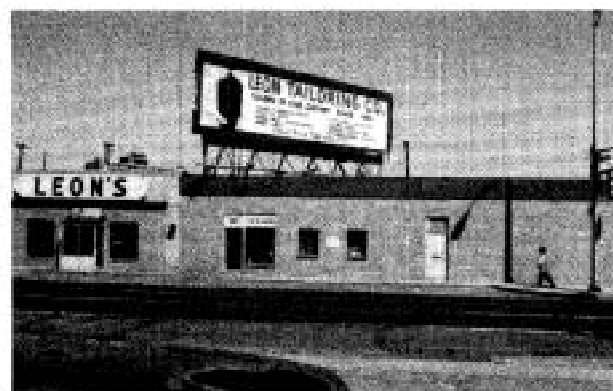
Commercial Building
809 North Delaware Street
circa 1954-1956

Architectural Description: This shop is now integrated into the neighboring building to the south and serves as the entrance and showroom for Leon Tailoring Company. It has classical elements of fluted end pilasters and an entablature with a molded cornice. The original shop front has been lost with undersized windows and brick filling the openings. Projecting from the center of the facade is an enclosed entrance vestibule.

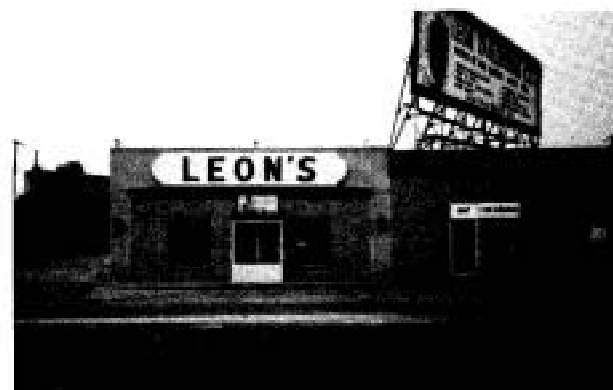
Commercial Building
814 North Delaware Street
circa 1941-1954

Architectural Description: This one-story concrete block building has a very plain brick facade, made plainer with subsequent alterations. The former storefront opening has been bricked up leaving only a steel-framed steel flush door. A soldier course lintel is found above the former storefront, and a secondary doorway to the south has also been bricked up.

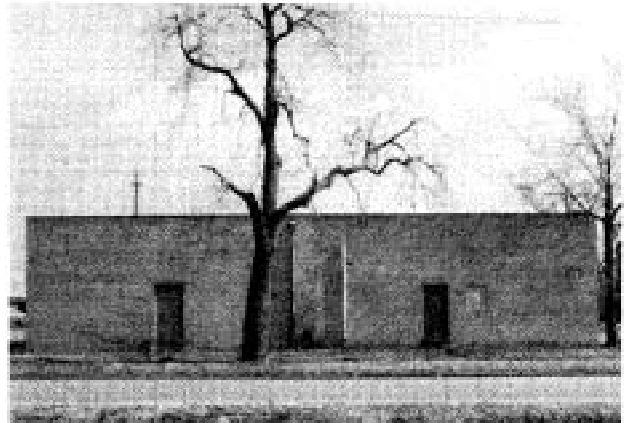
Industrial Building
1025-1027 North New Jersey Street
circa After 1969

Architectural Descriptions: This starkly plain, concrete block industrial building has a flat roof, tile parapet coping, two doors, a small window opening and a drain scupper on its street facade.

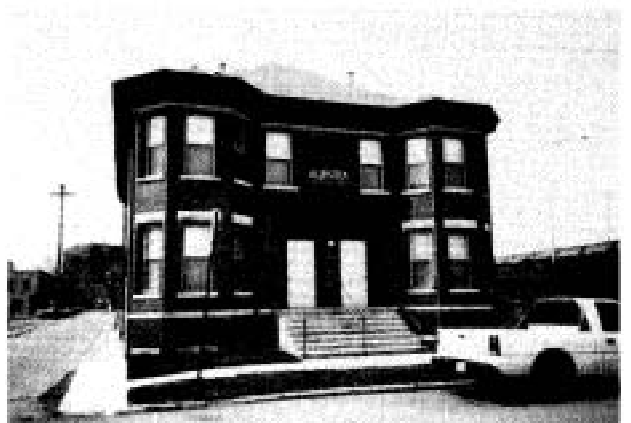
Architectural Description: The Aurora Apartment Complex is one half of a tandem apartment with its companion The Apollo immediately to the east. The Aurora is a two-story brick apartment building. The building has two street facades. The New Jersey Street facade is symmetrical with two corner bays, a low-pitched hip roof, sheet metal cornice and rock-faced limestone sills, lintels, architrave and water table. Stamped sheet metal wreaths and swags and cornice ornament the entrance. A large tablet with Aurora in relief with the legend Aurora is centered on the facade at the second story level. The 11th Street facade is a series of four bays and steeped entrances.

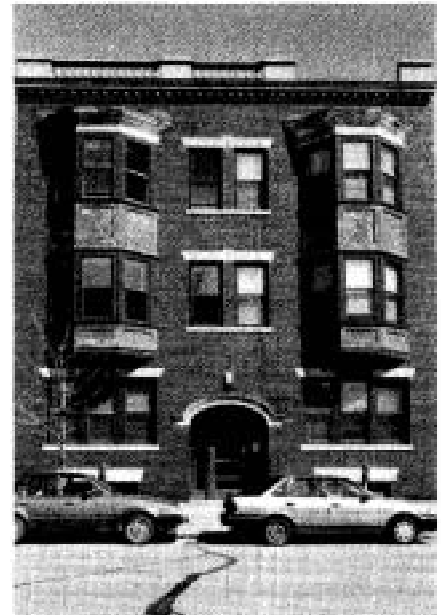
The Grover
615 N. Pennsylvania
circa 1913

Architectural Description: Constructed of red brick, the Grover is an I-shaped building, three-stories high and eight bays wide on its front (western) facade. The two central bays contains a recessed entrance with an elliptical transom light and narrow side lights. The entrance opening is crowned by a flat, limestone voussoir arch rising from spring blocks. Second and third floor windows in the central bay, arranged in pairs, have limestone sills and keyed lintels flush with the facade. The flanking bays use triple windows. Two-story bays are topped with a dentilled metal cornice. The facade is capped by a limestone frieze with large dentils and a limestone balustrade. The southern most section of the balustrade is missing.

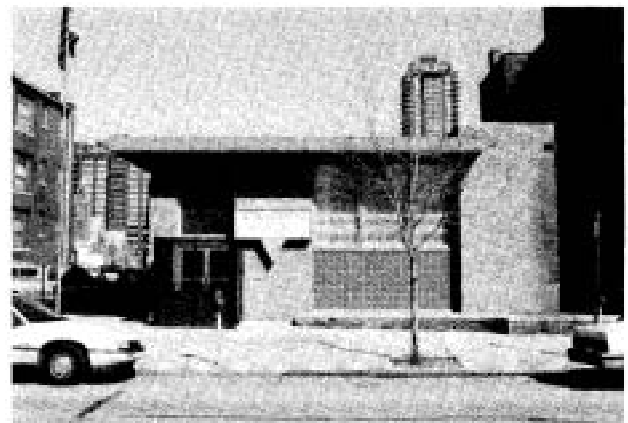
Forty et Eight, Voiture Locale N. 145
619 N. Pennsylvania
1953

Architectural Description: This club house exhibits strong International Style styling with the use of bold voids, slabs and recesses. The flat slab roof cantilevers and shades the front. A bank of windows in three vertical bands has a glazed green tile apron. The entrance is protected by an added metal and glass entry vestibule. The near center vertical brick slab bears the sign of the organization.

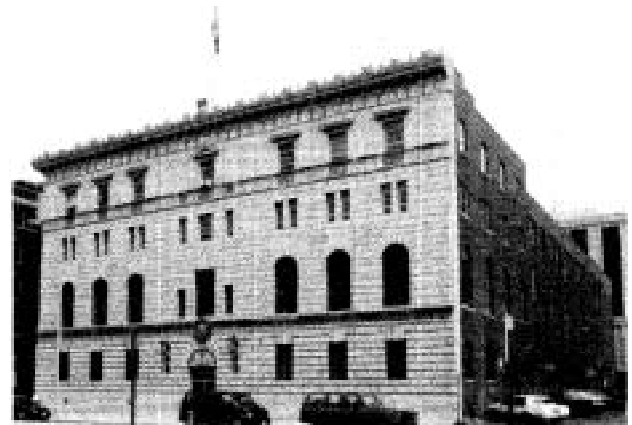
YWCA Blue Triangle Residence Hall
725 N. Pennsylvania
1923-1924

Architectural Description: The Blue Triangle building is a significant example of the early twentieth century Neoclassical Revival style. It was designed by the prolific and highly respected Indianapolis architectural firm of Rubush and Hunter, and was built by the noted local construction firm of William Jungclauss and Company. The building is a five-story, steel frame red brick structure built on a raised, brick faced foundation. The front (western) facade is made up of seven bays that feature limestone sills, belt courses, and keystones. The limestone entrance surround exhibits a full pediment with entablature resting on scrolled brackets with a band of dentils. The original triangular blue metal sign reading "Residence Hall" still hangs outside the building.

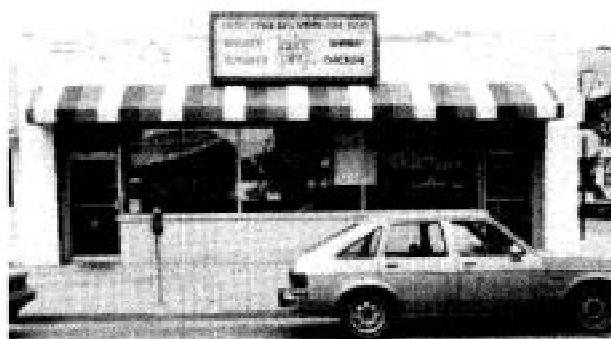
Commercial Building
901 N. Pennsylvania
circa 1930

Architectural Description: This one-story brick commercial building has a remodeled store front with metal framed windows and doors and a glazed, green tile apron below the limestone window sills. Concrete pilinths help define the end piers.

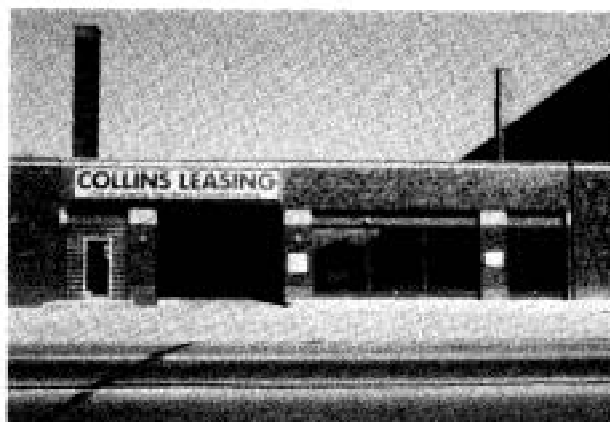
Arvey Building
1021 N. Pennsylvania
1978

Architectural Description: This one-story commercial building is constructed of concrete blocks laid to flute the exterior. The entrance is centered and emphasized by the slightly projecting sheet metal false mansard roof. The windows are narrow vertical slits.

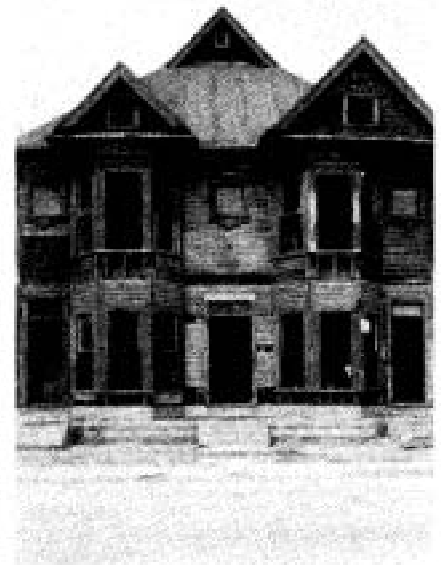
St. Joe Flats
134-38 East St. Joseph Street
circa 1900

Architectural Description: The building is nearly identical to its companion immediately to the west, except for a centered hip roof dormer.

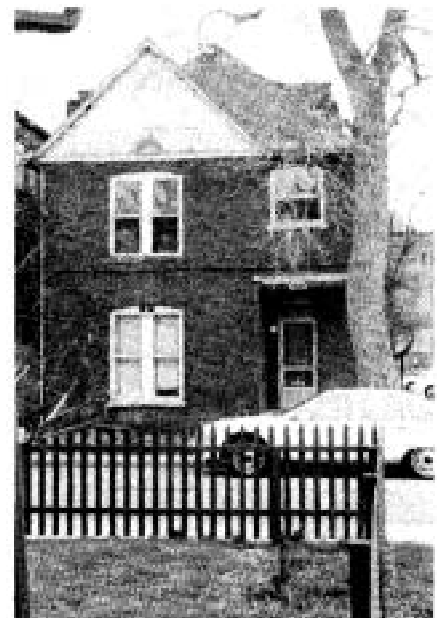
Tomlinson-Smith House
238 East St. Joseph
circa 1866

Architectural Description: This two-story frame house has a cross gable roof and an "L" plan veranda. The veranda has an entry gable, turned posts and balustrade. The front gable has decorative shingles and a Gothic inspired gable vent. The porch was reconstructed.

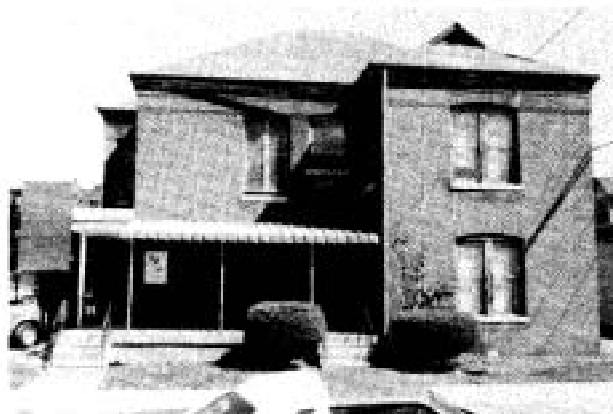
Cottage
114 East 9th Street
circa 1860

Historic Description: This cottage was constructed sometime between 1854 and 1866, and has had very little alteration, except for construction of a front porch which was added sometime after 1969.

Architectural Description: A simple, frame one-and-one-half-story cottage two bays wide, with a front porch supported by turned posts and balustrade. Eave rafter tails enhance this building's appearance. It is clad with clapboards and covered by a gable roof with side dormers.

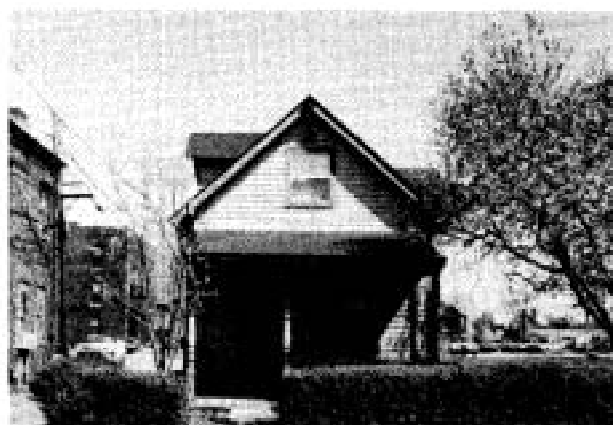
Dorman House
115 East 9th Street
circa 1875

Historic Description: Barbara Dorman owned the property when this house was constructed sometime between 1866 and 1877. She and her heir, Caroline Dorman, owned the property from 1859 until 1903. The house has changed little over time. A front porch was added after 1913, and removed after 1969, probably when the aluminum siding was added.

Architectural Description: Despite the artificial siding, the canopy and shutters, this one-and-one-half story cottage retains most of its original features. The gabled front facade is three bays wide with a full-sized window centered in the upper level. Other features include the double hung sash windows, decorative eaves brackets, sawn rounded garret vents and the slightly recessed entryway. A shed dormer is perched on the western slope of the roof.

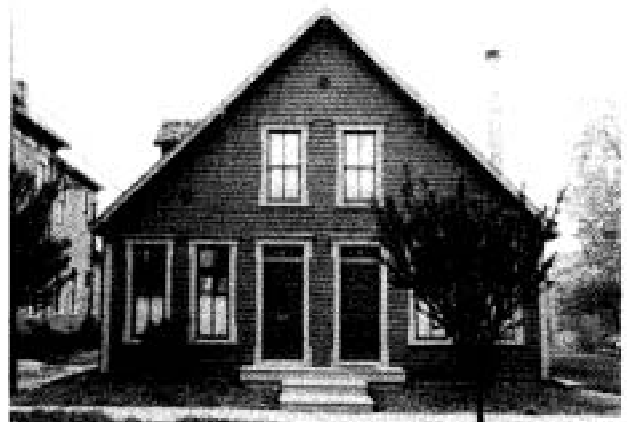
Thudriss-Halford House
218 E. 10th Street
1865

Historic Description: Johann Thudriss constructed this house in 1865, and sold it in the same year to Ann Halford, whose family owned it for a decade. By 1887, a front porch was added and by 1896, this porch grew into a wraparound veranda. By 1922, the house was listed as containing five apartments.

Architectural Description: This two-story frame house exhibits Italianate styling in its elongated, four-over-four windows, door and opening fenestration trim and two-story bay. The house has an "L"-shaped plan, a cross gable roof and a corner entrance porch. The main entrance door has sidelights and a transom.

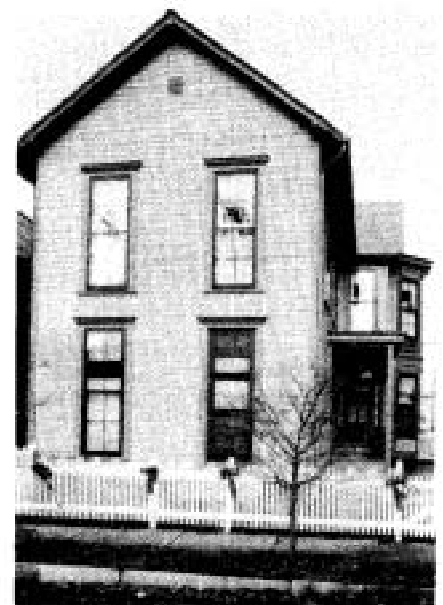
Moody House
219 E. 10th Street
circa 1875

Historic Description: Lorenzo and Mary Moody had this house constructed and the family maintained residence here until 1917. Lorenzo Moody was a prominent member of the Indianapolis insurance industry and was a charter member of the Indiana Association of Underwriters. Soon after the Moody's left the house, it was used for multiple dwelling units with six apartments.

Architectural Description: The two-story frame Italianate house exhibits features typical of this style including a low-pitched hipped roof, a bracketed entablature with frieze lights, a two-story bay and a canopied off center entrance, slightly recessed. A side porch has turned posts and decorative cut-out panels.

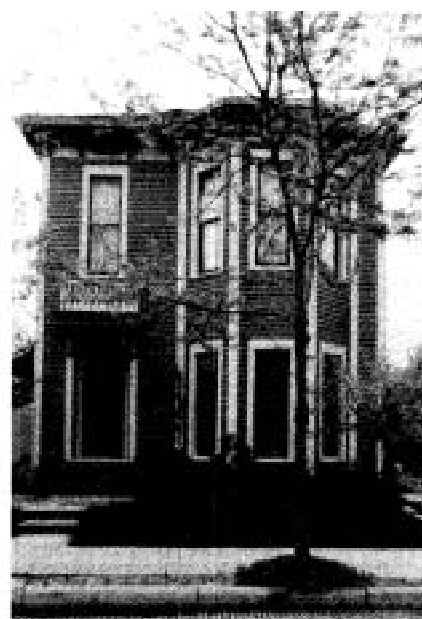
Wilmington House
222 E. 10th Street
circa 1875

Historic Description: The Wilmingtons owned this property from 1865 until the mid 20th century. They had this house constructed sometime between 1866 and 1887. Wilmingtons were owner-occupants from circa 1913 until the early 1940's. By 1929, the house was converted to a four unit apartment house. The wrap-around veranda was added circa 1900, replacing the smaller, original corner porch. Original porch supports have been replaced by steel posts.

Architectural Description: Before its remodeling, this two-story frame house undoubtedly exhibited Italianate detailing, but the basic forms of the style remain, including the low-pitched hip roof, elongated windows and a wide overhang, veranda columns, asbestos shingle siding, and the numerous first floor entrances all detract from the house's original appearance.

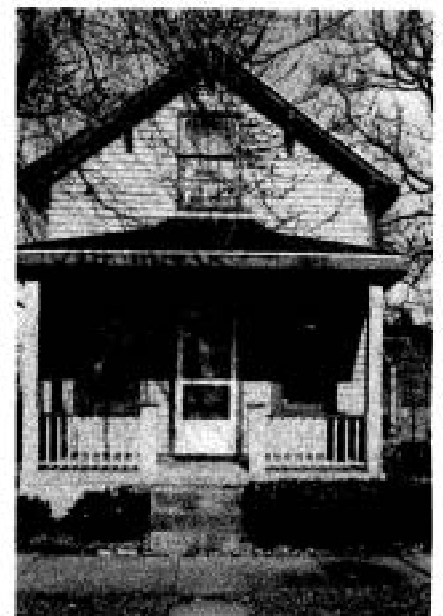
Sickler House
311 East 10th Street
circa 1880, moved 1992

Historic Description: This house was constructed sometime between 1871 and 1887 at 220 East 11th Street, and moved to this location, November 4, 1992. Alice and Edward Sickler were longtime residents from 1910 to 1929, but the Sickler family had owned the house since the 1890's. Except for its relocation, the building history shows that the house has changed very little.

Architectural Description: Devoid of details, the two-story frame house retains its form, original cladding and openings. The decorative rafter ends have survived.

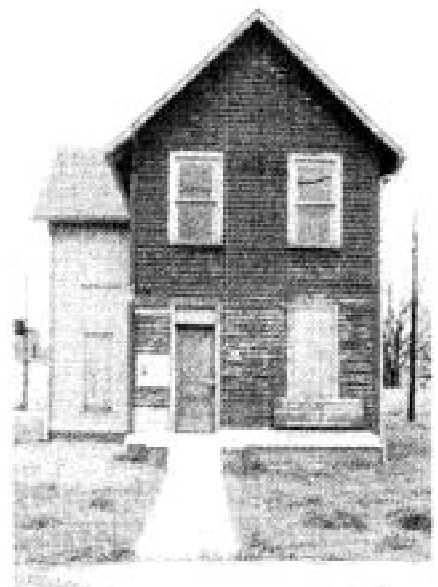
Howe Rental House
316-318 East 10th Street
circa 1885

Historic Description: David W. Howe purchased the lot from platter Elijah Martindale in 1885, and later constructed this house sometime before 1887. The two-story house appears to have always been a rental property with many short term tenants.

Architectural Description: It is a two-story frame, Queen Anne Style house, with a hip and cross-gable roof. The front gable is shingled with brackets, stick work and a decorative gable vent. The house has a small corner porch with decorative features.

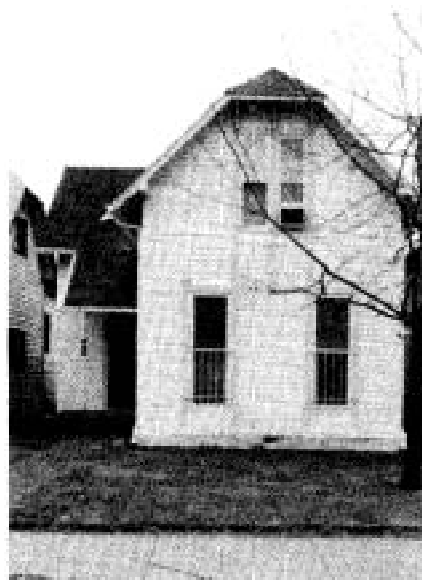
Hefferman-Murphy Cottage
327 East 10th Street
circa 1887

Historic Description: This cottage was constructed sometime between 1866 and 1887. Thomas Hefferman, a carpenter, occupied the house from 1911 to 1917, followed by a series of short-term occupants until Carl Murphy in 1920, who remained for over thirty years.

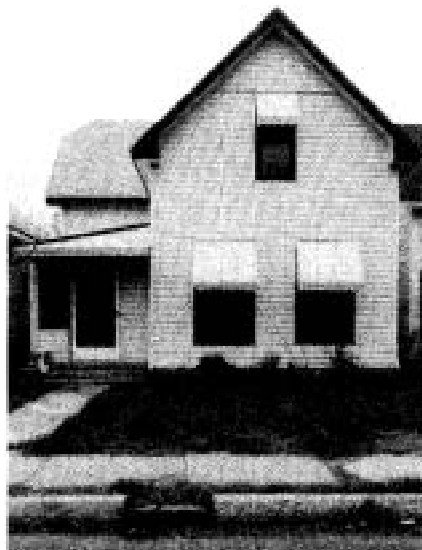
Cottage
329 East 10th Street
circa 1880

Historic Description: This cottage was constructed sometime between 1866 and 1887, and in this century, has had a long succession of short-term occupants. The building's form has changed very little since 1898.

Architectural Description: The one-story frame cottage has a corner entrance and a projecting front bay with a shed roof. The application of artificial siding has either covered or caused the removal of architectural details.

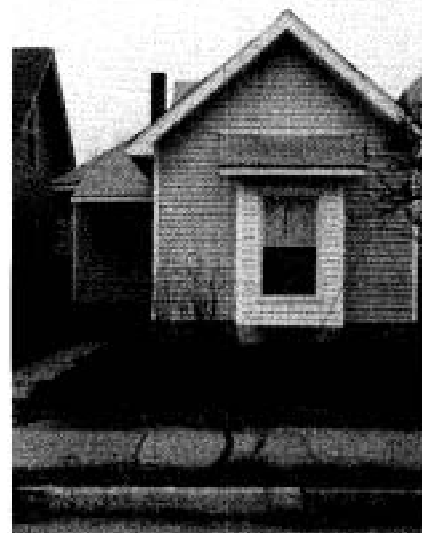
Smith-Dowell-Glass House
331 East 10th Street
circa 1880

Historic Description: This house was built sometime between 1866 and 1887, and its basic form has changed very little since 1887. Nathan Smith, a dry-goods merchant, occupied the house from 1919 to 1929, followed by Susan Dowell from 1934 to 1945, and Emma Glass, a widow, between 1949 and 1965.

Architectural Description: This one-and-a-half-story frame house has a cross-gable roof with gable brackets and a small corner entrance porch with turned posts. Presently, the house is covered with artificial siding. Paired windows are a feature of the front gable facade.

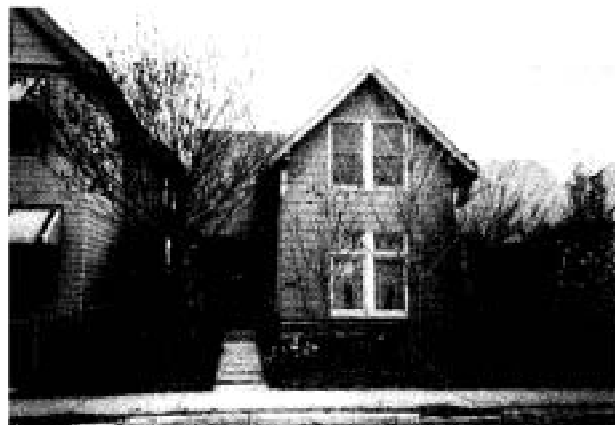
Canter House
333 East 10th Street
circa 1880

Historic Description: This house was constructed sometime between 1866 and 1887. Carpenter Henry Canter was the occupant in the 1910's and early 1920's. Lonnie Clayton, a painter, lived here in the 1950's. John and Bertha Hunter occupied the house from the late 1960's to the early 1990's. The form of the house has not changed its basic look since 1887.

Architectural Description: The two-story, frame house has a cross-gable roof, cornice brackets, wide bargeboards and a shallow side porch. The house is covered with asbestos tile siding.

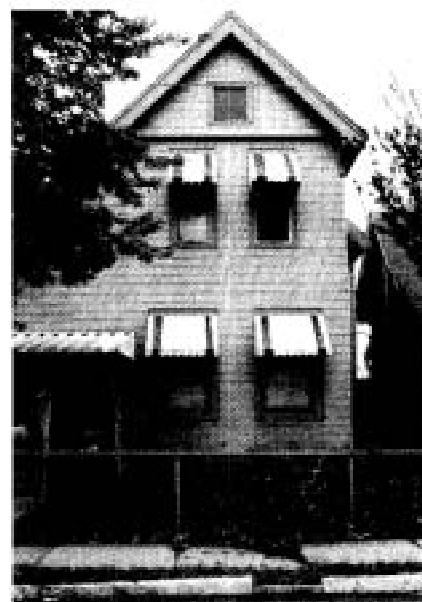
House
216 East 11th Street
circa 1920

Historic Description: This house was constructed sometime between 1916 and 1927 on the back lot of 1104 North Delaware.

Architectural Description: The two-story frame has Arts and Crafts features with the low-pitched hip roof and wide eaves. The main facade (south) has an unusual fenestration pattern.

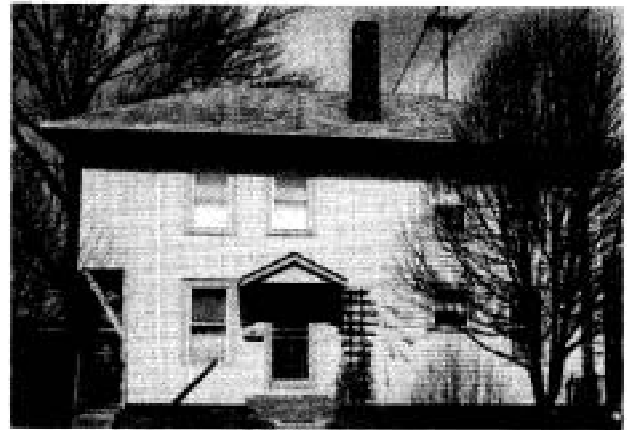
Tramer House
219 East 11th Street
circa 1870 & circa 1890

Historic Description: Constructed some time between 1866 and 1887, this house was substantially enlarged before 1898 to its present configuration. Long-time occupants were Elias & Anna Tramer, from 1891 to the early 1940's. The Tramer's were responsible for the expansion in 1893. The next owner-occupants, Franklin and Florence Taylor resided here from 1946 to the late 1970's.

Architectural Description: This Queen Anne Style, two-story, frame house has a hip and gable roof. Fishscale shingles clad the front gable. The "L" plan veranda is supported by replacement square posts. Other features include a rusticated concrete block veranda foundation, door transom and corner blocks decorating the window trim.

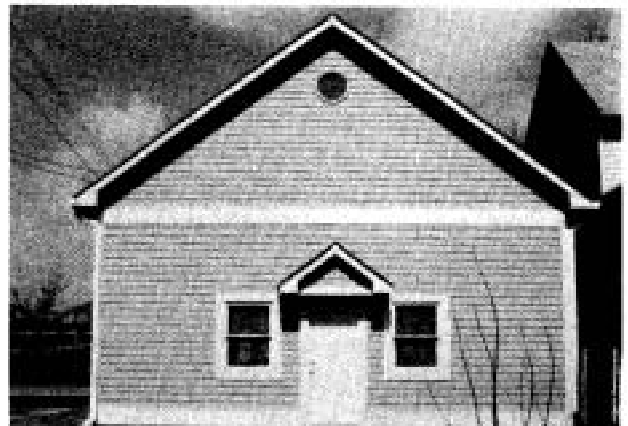
Burnham-Davis Cottage
225 E. 11th Street
circa 1890

Historic Description: This cottage was constructed sometime between 1887 and 1898, possibly during the ownership of George and Lillian Burnham. The house enjoyed the stable occupancy of Henry Davis from 1917 until the late 1920's.

Architectural Description: The one-story frame cottage is gable fronted, and two bays wide. The "L" plan front porch with entry gable is supported by turned posts. The main roof is gable and hip with a Gothic inspired gable vent.

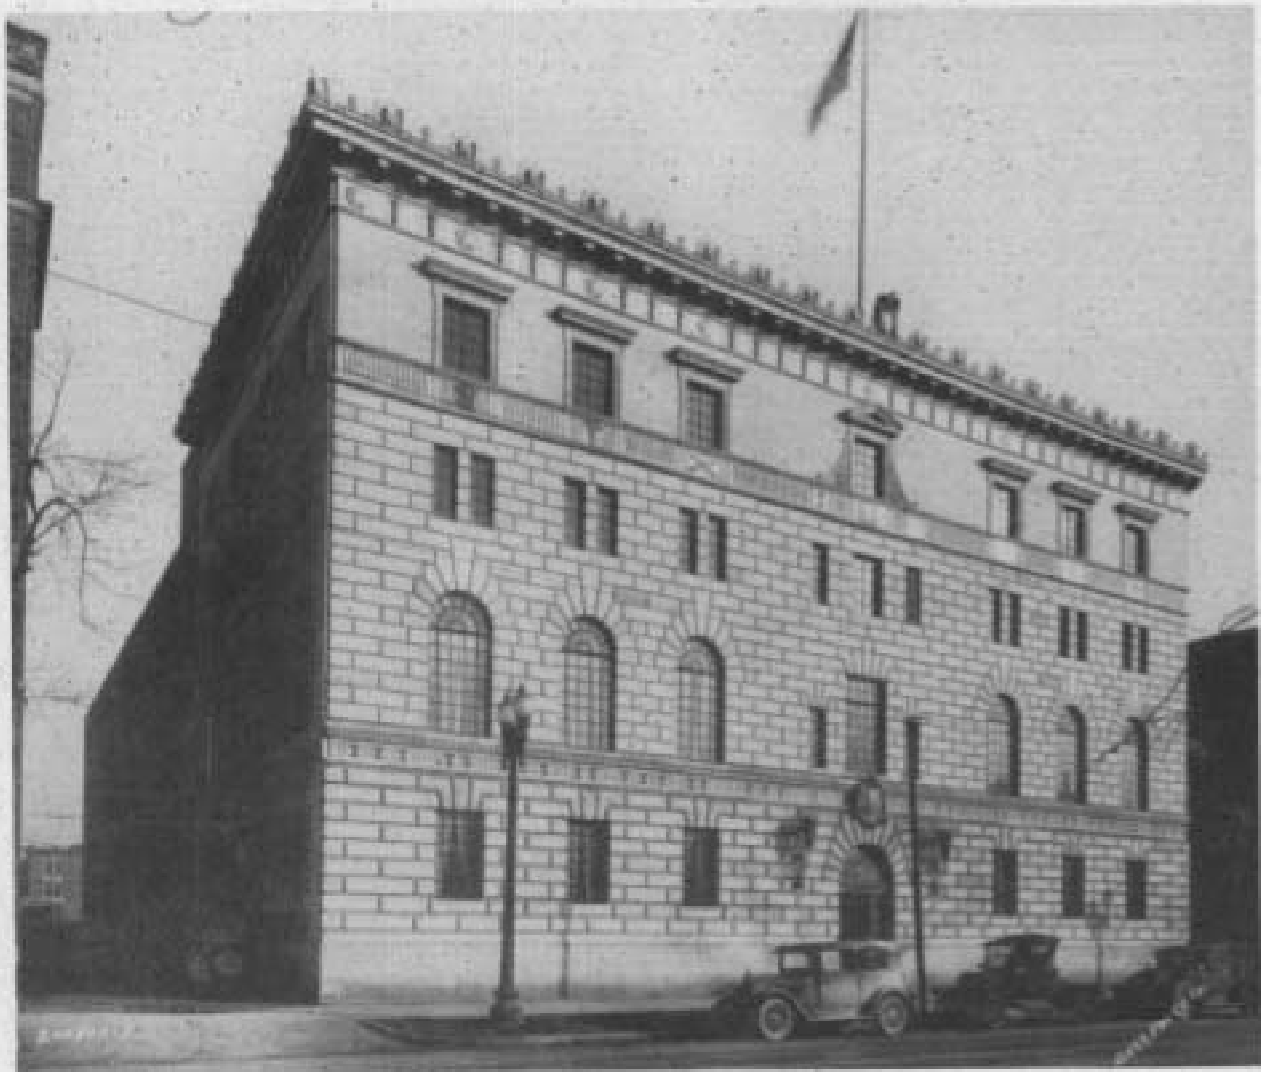
Tyndall Armory, 711 N. Pennsylvania Street. February 1, 1927. Photograph by Bass Photo Co. Collection, Indiana Historical Society Library. (Negative #200903).

The Tyndall Armory is a response to the 1920s World War Memorial Plaza and American Legion Headquarters across the street. It is significant for its historical association with General Robert H. Tyndall, a founder of the American Legion and eight-year National Treasurer, and Indianapolis mayor and businessman. The Tyndall Armory, cited in Indianapolis Architecture for its "fine Florentine facade with rusticated base" is faced with limestone on the front facade and features elaborate polychromatic terra cotta detailing in friezes, cornice, and most notably in the edges and shields that crest the flat roofline. The terra cotta details are the work of the talented Estonian-born architectural sculptor Alexander Sangernebo depicting the insignia of the different branches of the armed forces.

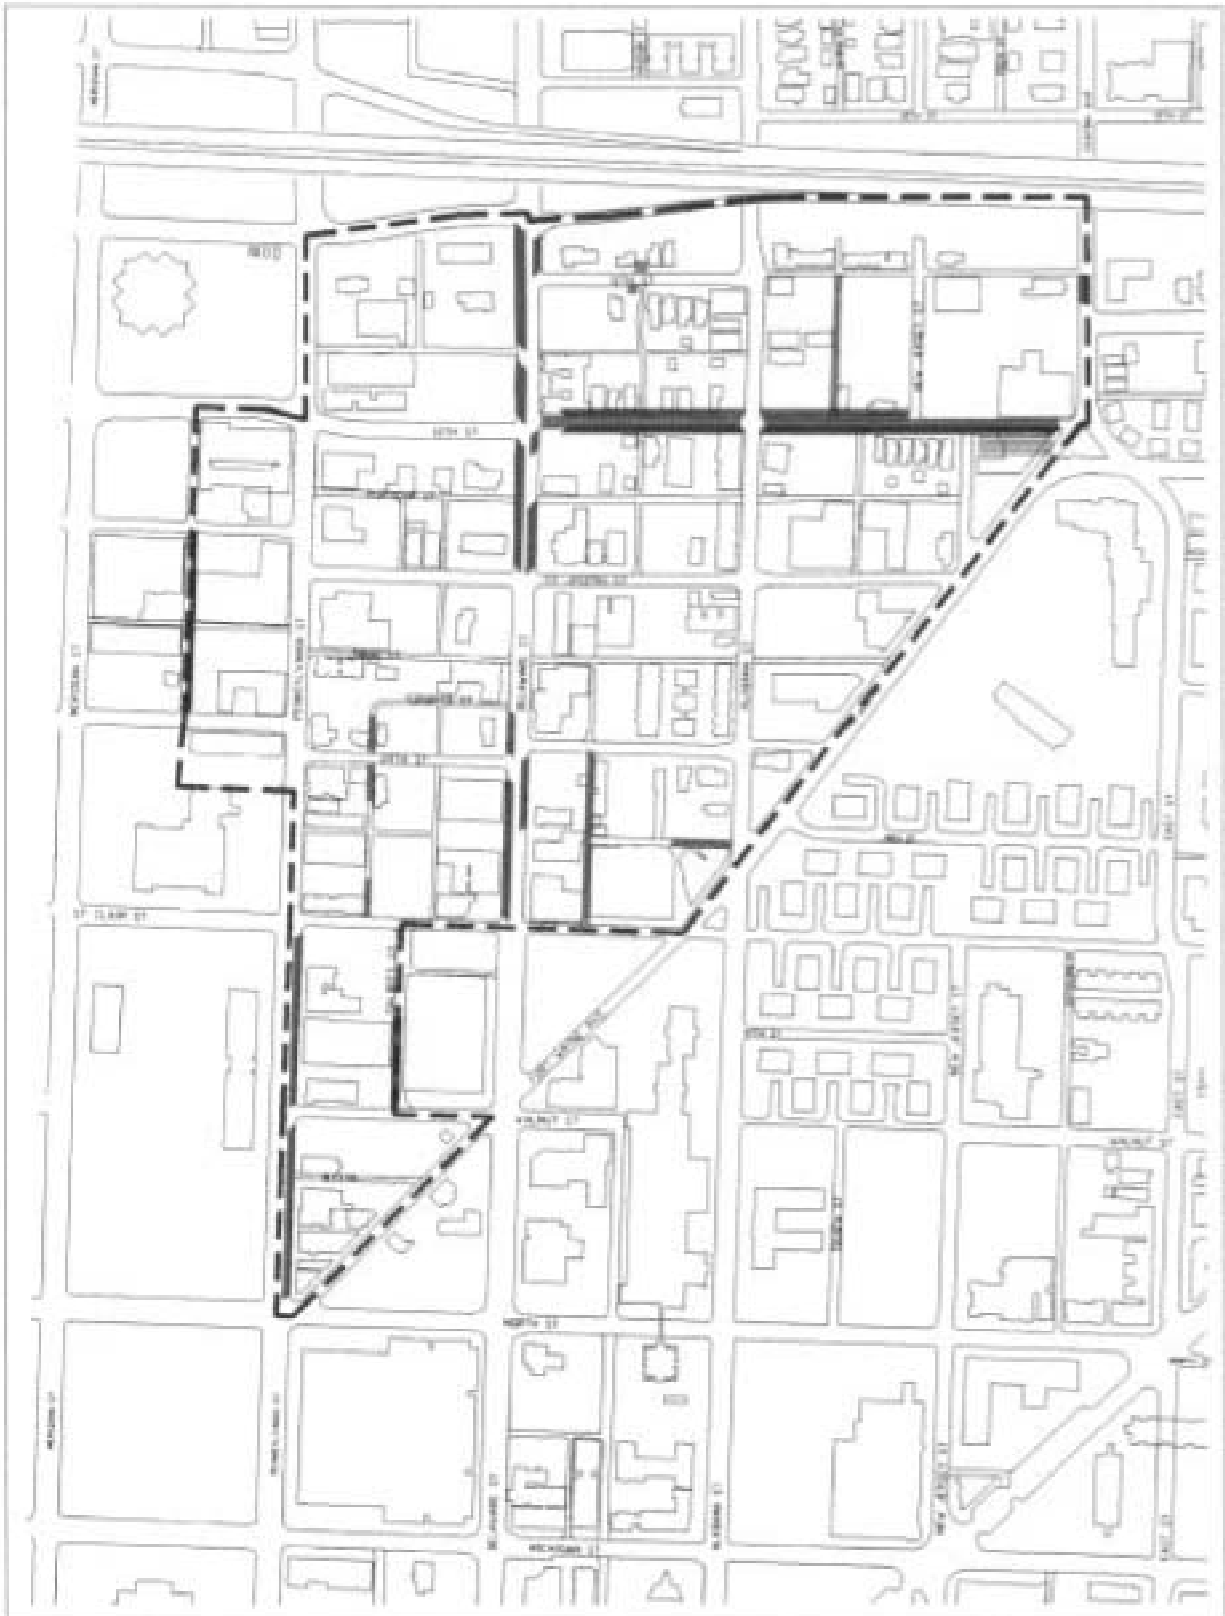
BRICK STREET OR ALLEY

Part of the historic character of the St. Joseph historic area is contained in its visible historic infrastructure, which consists mainly of streets, alleys, and curbs. Only one significant section of brick street remains, 10th Street between Delaware Street and Central Avenue. The only remaining brick sidewalk is located in a stretch of 10th Street between Central Avenue and New Jersey Street. Many brick alleys can be found throughout the district with the longest and most intact being Ogden Street (an alley with a street name).

Approximately five blocks of brick-paved alleys still exist. Their condition varies from poor to good. Odgen Street, a named alley, is in the best condition of all.

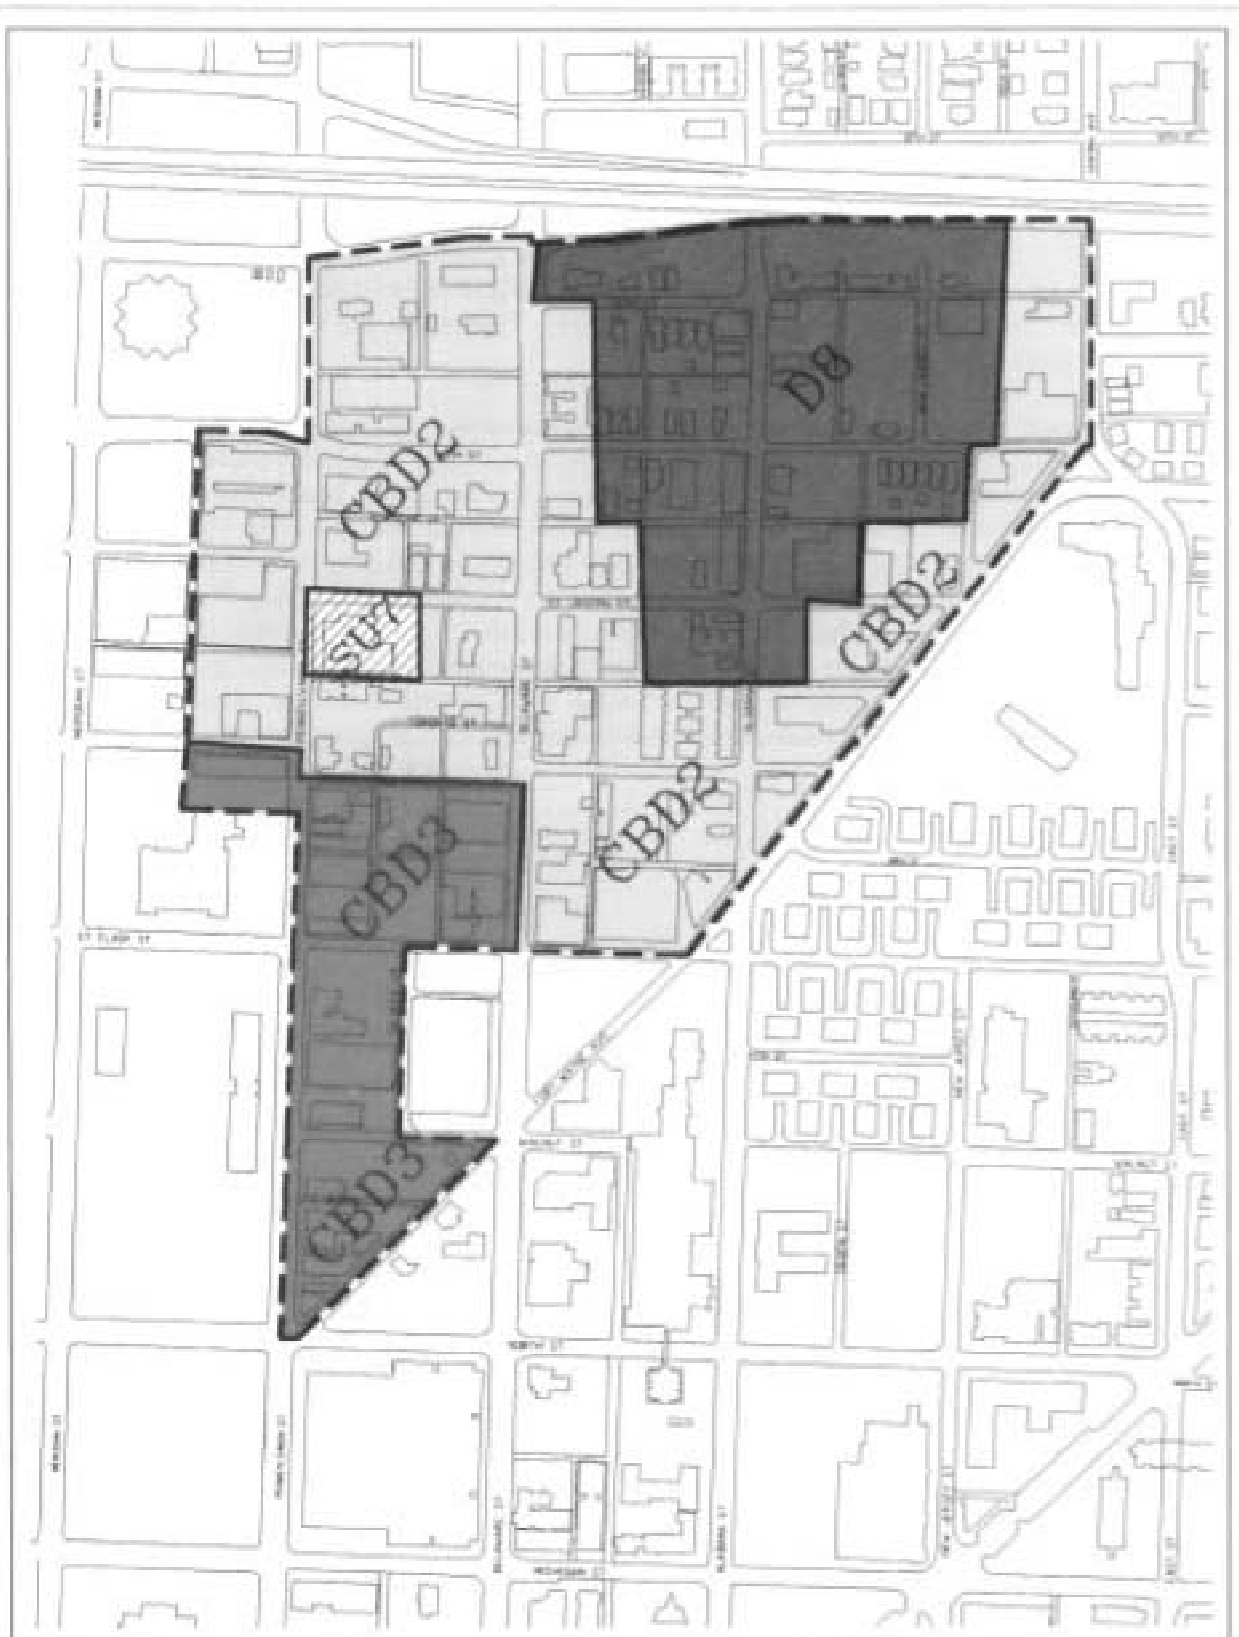
CBD2

The zoning recommendations shown on Recommended Zoning Map and contained in the text of the Land Use Recommendations are to be used only as a guide to determine the most desirable zoning classification for property within the district. Approval of this plan does not change any zoning in the historic area. Variances and rezonings can only be accomplished through petitioning the Historic Preservation Commission and the Metropolitan Development Commission.

For the most part the existing zoning is satisfactory and is recommended to stay the same. Nevertheless, two major changes in zoning are proposed for the land currently zoned for Community- Regional Commercial C-4. Specifically, the land that has been proposed as the residential core in the Land Use Recommendations should be rezoned to D-8 Dwelling District which is designed to provide for the wide range and mixture of housing types found in older, inner-city neighborhoods such as St. Joseph. D-8 dwelling District corresponds to the high density residential classification of the Marion County Comprehensive Land Use Plan. Also, the area outside of the proposed Residential Core and currently zoned Commercial C-4 is recommended for rezoning to Central Business District CBD-2. a classification that allows a wide variety of residential and commercial uses.

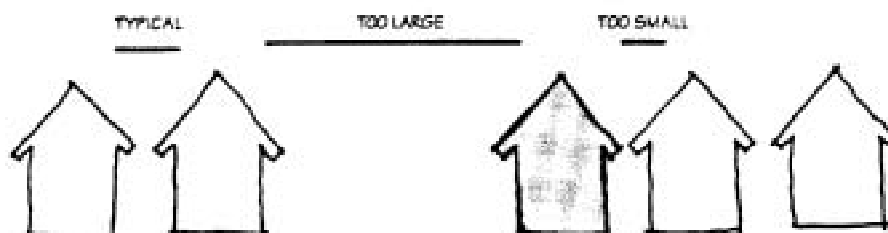
BUILDING HEIGHTS: The actual height of buildings and their various components as measured from the ground.

NOTE: In areas governed by this plan, heights should be determined using these guidelines rather than those noted in the zoning ordinance.

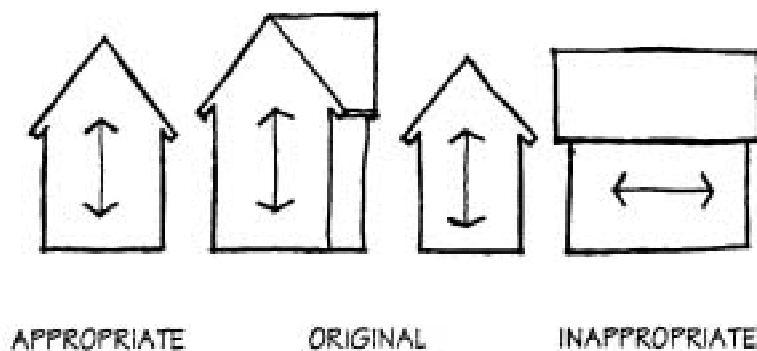
MASS: The three dimensional outline of a building.

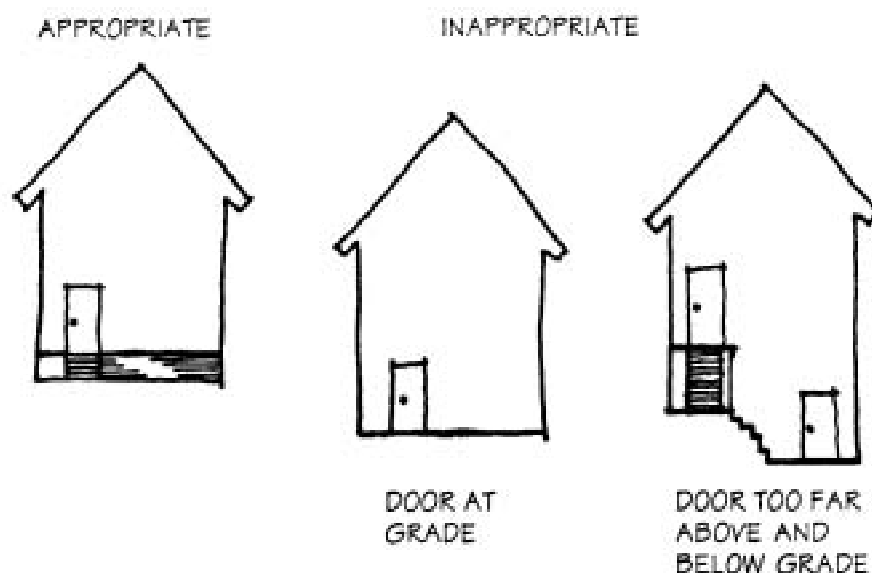
ENTRY: The actual and visually perceived approach and entrance to a building.

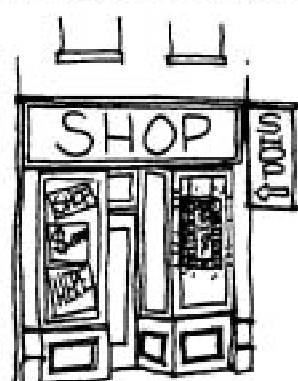
INAPPROPRIATE SIGN LOCATIONS AND TYPES

9. Flashing or animated signs.
10. Roof signs.
11. A projecting sign, unless it is pedestrian oriented and its location, size, style, method of attachment, material and lighting is compatible with the building to which it is attached as well as its surrounding context.
